Clinical Management of Hip Arthroplasty

# Practical Guide for Handling Noises in Hard-on-Hard Bearings

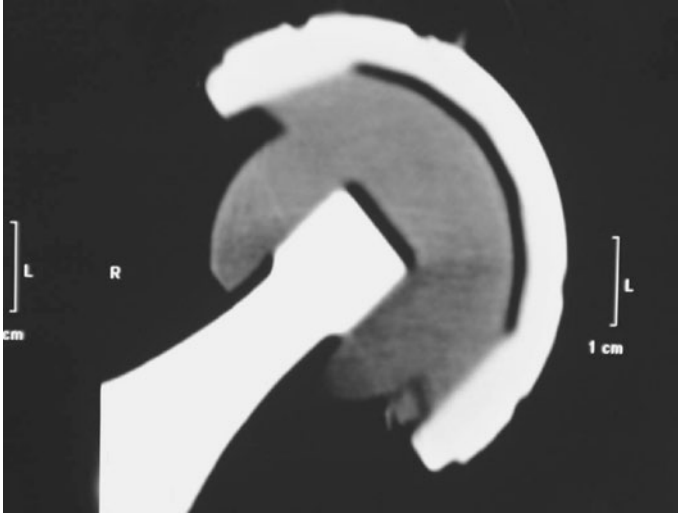
■ Fig. 5 Coronal computer tomogram of the ceramic insert in case 2 showing rim fracture.

A 64-year-old woman had a ceramic-on-ceramic hip replacement (36-mm bearing, Biolo<sup>x</sup>®forte, CeramTec, Plochingen) 3 years earlier. She had been doing well until she noticed an intermittent “crunching and grating” noise in her hip with no specific activity. The noise then started occurring with any movement of the hip but was not accompanied by pain. Check-up radiographs and CT scans showed a fracture in the rim of the ceramic liner (■ Fig. 3, ■ Fig. 4, ■ Fig. 5).
